Project Information

Project Name: E911

Metadata Information

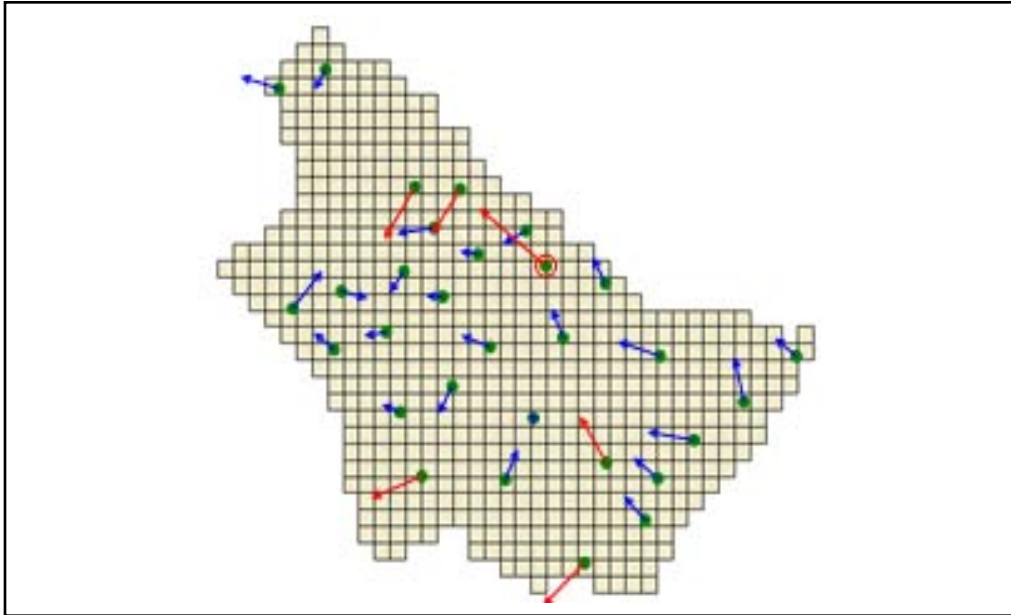
Vector Offset

Scaling Factor: 10000

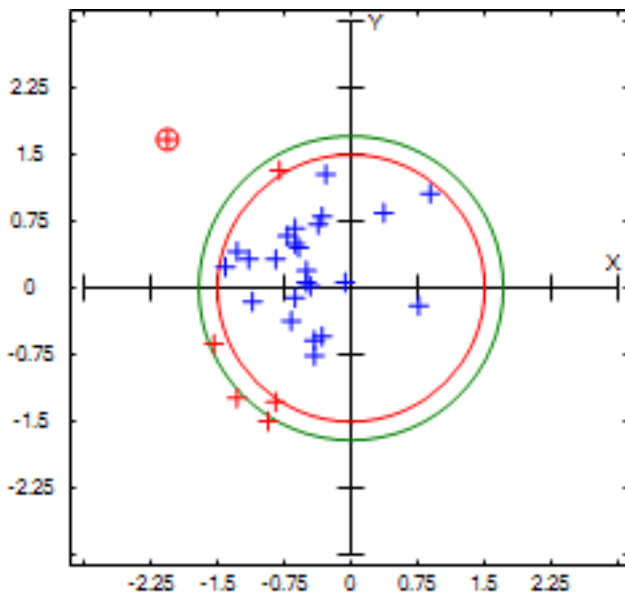
Circular Error

| CE 90: | 1.5 | CE 95: | 1.711 | CI: | 0.25 |
