## Project Information

Project Name: E911

## Metadata Information

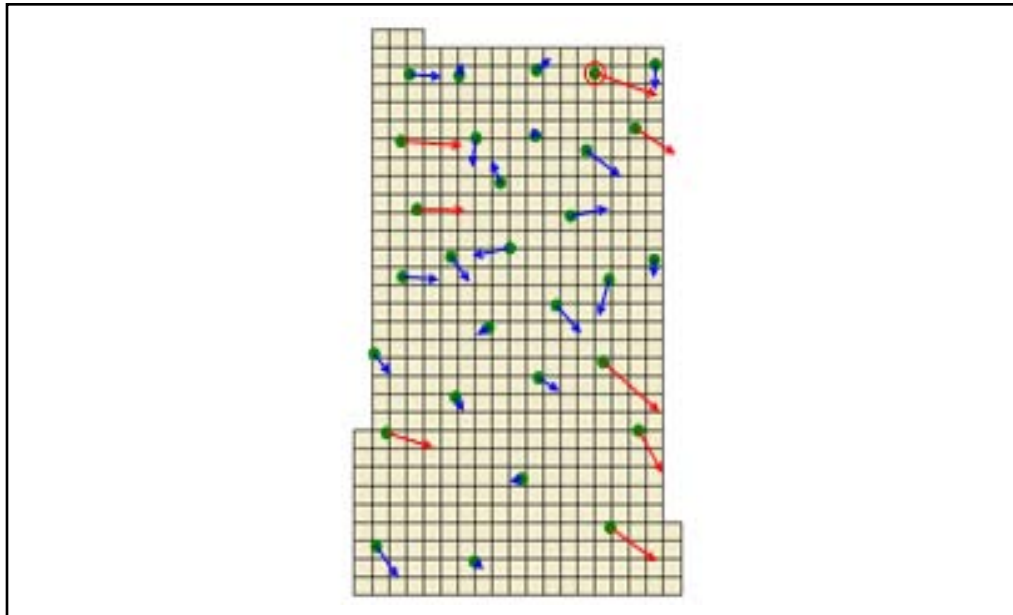
### Vector Offset

Scaling Factor: 10000

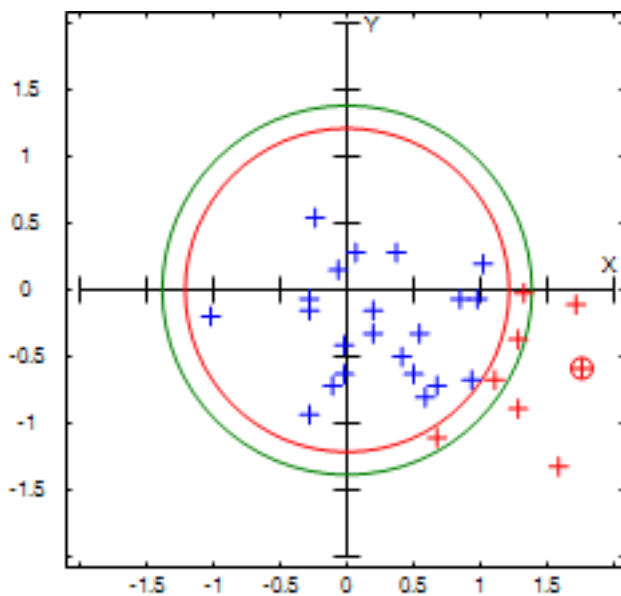
### Circular Error

Min $\Delta X$ :	-1.02	Min $\Delta Y$ :	-1.324	SX:	0.687
Max $\Delta X$ :	1.758	Max $\Delta Y$ :	0.543	SY:	0.444
Mean $\Delta X$ :	0.524	Mean $\Delta Y$ :	-0.366	SH:	0.566
Skew $\Delta X$ :	0.002	Skew $\Delta Y$ :	-0.048		
RmseX:	0.855	RmseY:	0.57	RmseH:	1.027
SRMSE H:	0.103				
CE 90:	1.214	CE 95:	1.384	CI:	0.202
No. Observations:	30				
Horiz. Bias:	0.639		NSSDA:	1.743
