Project Information

Project Name: E911

Metadata Information

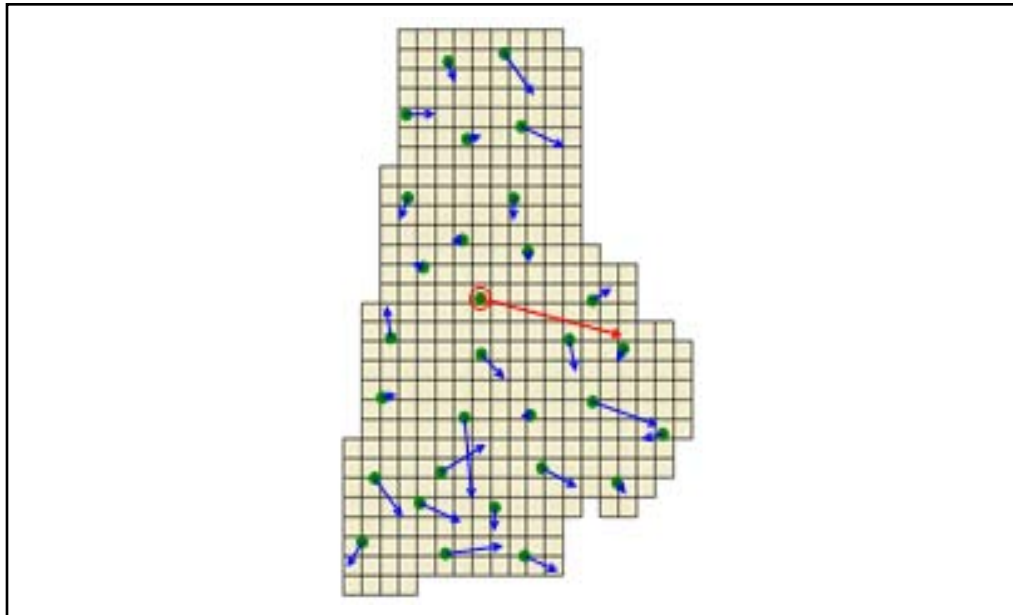
Vector Offset

Scaling Factor: 10000

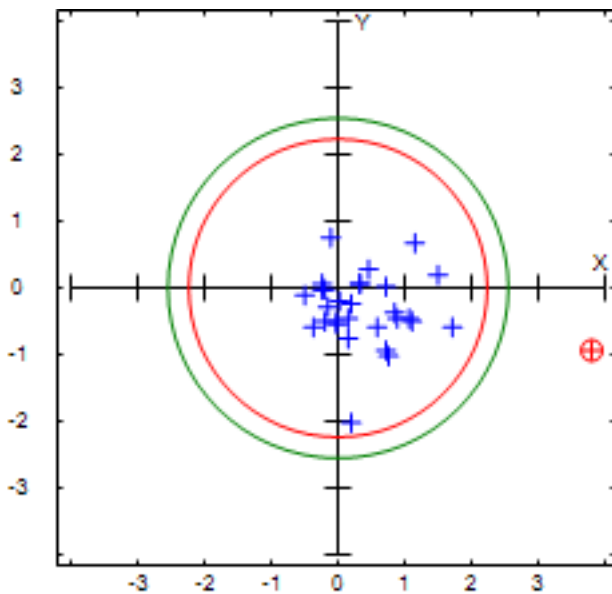
Circular Error

Min ΔX:	-0.499	Min ΔY:	-2.018	SX:	0.975
Max ΔX:	3.798	Max ΔY:	0.76	SY:	1.108
Mean ΔX:	0.488	Mean ΔY:	-0.331	SH:	1.041
Skew ΔX:	2.2	Skew ΔY:	-0.656		
RmseX:	0.964	RmseY:	0.622	RmseH:	1.147
SRMSE H:	0.19				
CE 90:	2.235	CE 95:	2.549	CI:	0.373
No. Observations:	30				
Horiz. Bias:	0.589		NSSDA:	1.941
