Project Information

Project Name: E911

Metadata Information

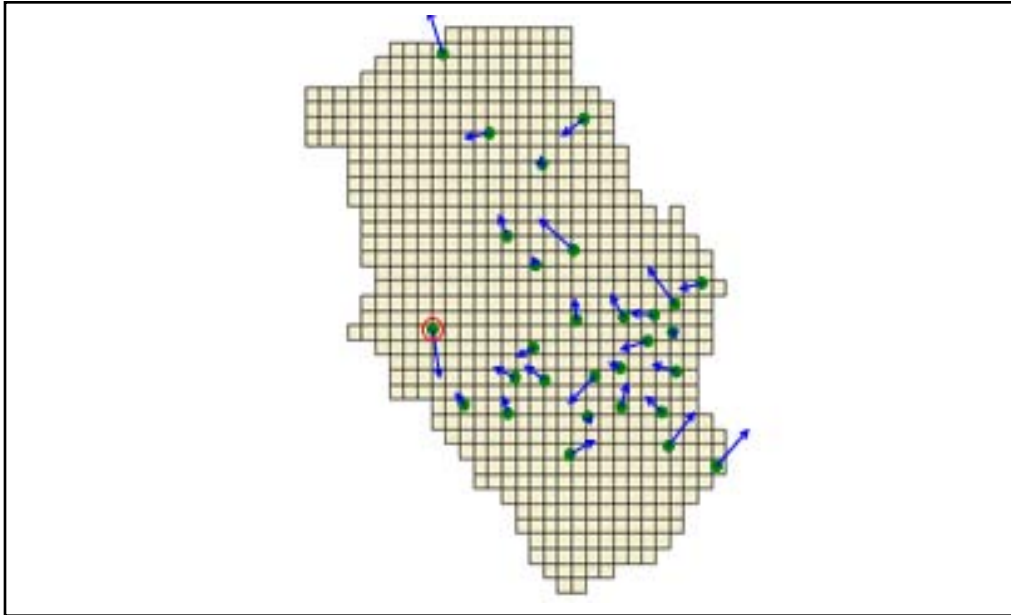
Vector Offset

Scaling Factor: 10000

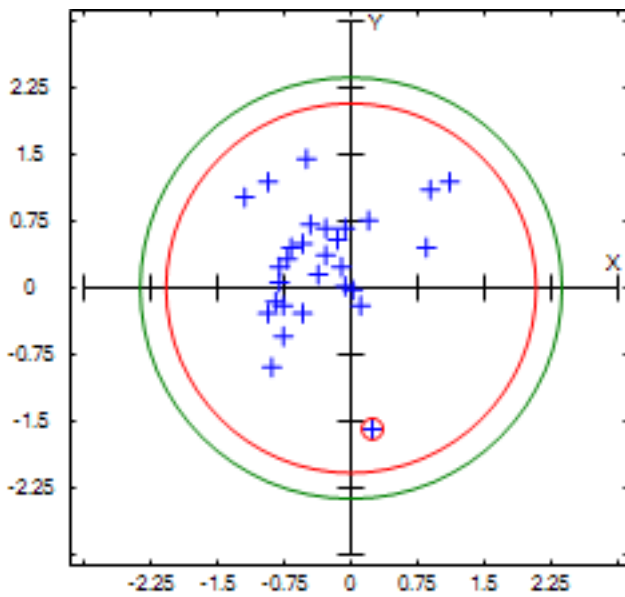
Circular Error

Min ΔX :	-1.194	Min ΔY :	-1.584	SX:	1.145
Max ΔX :	1.107	Max ΔY :	1.454	SY:	0.792
Mean ΔX :	-0.32	Mean ΔY :	0.276	SH:	0.968
Skew ΔX :	0.942	Skew ΔY :	-0.631		
RmseX:	0.651	RmseY:	0.705	RmseH:	0.96
SRMSE H:	0.18				
CE 90:	2.078	CE 95:	2.37	CI:	0.352
No. Observations:	29				
Horiz. Bias:	0.422		NSSDA:	1.66

Threshold: CE90: 2.078
