## Project Information

Project Name: E911

## Metadata Information

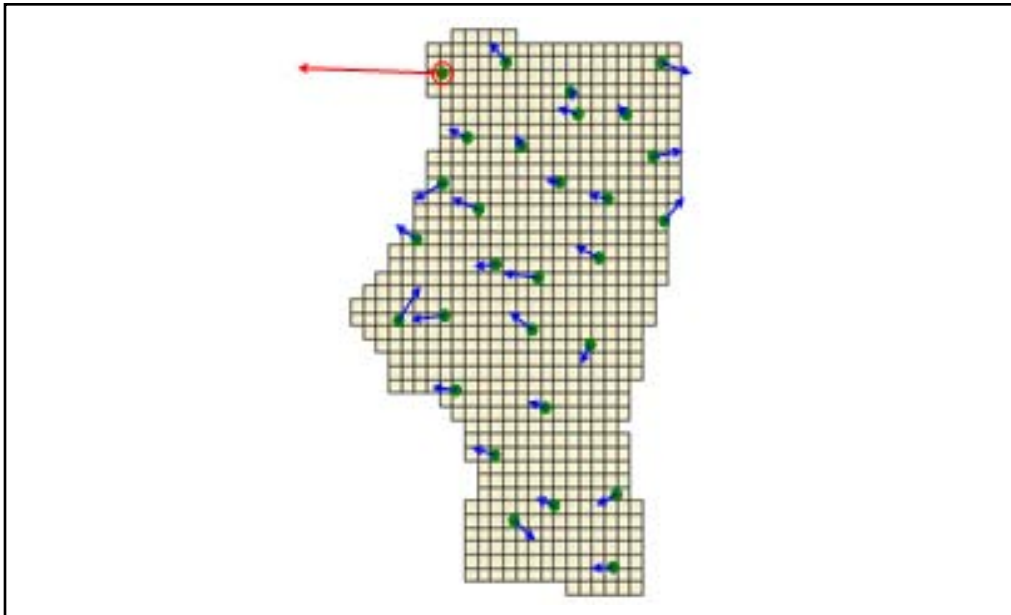
### Vector Offset

Scaling Factor: 10000

Min $\Delta X$ :	-5.621	Min $\Delta Y$ :	-0.673	SX:	1.173
Max $\Delta X$ :	1.063	Max $\Delta Y$ :	1.194	SY:	0.417
Mean $\Delta X$ :	-0.593	Mean $\Delta Y$ :	0.149	SH:	0.795
Skew $\Delta X$ :	-2.639	Skew $\Delta Y$ :	-0.008		
RmseX:	1.296	RmseY:	0.436	RmseH:	1.368
SRMSE H:	0.148				
CE 90:	1.706	CE 95:	1.946	CI:	0.289
No. Observations:	29				
Horiz. Bias:	0.612		NSSDA:	2.12

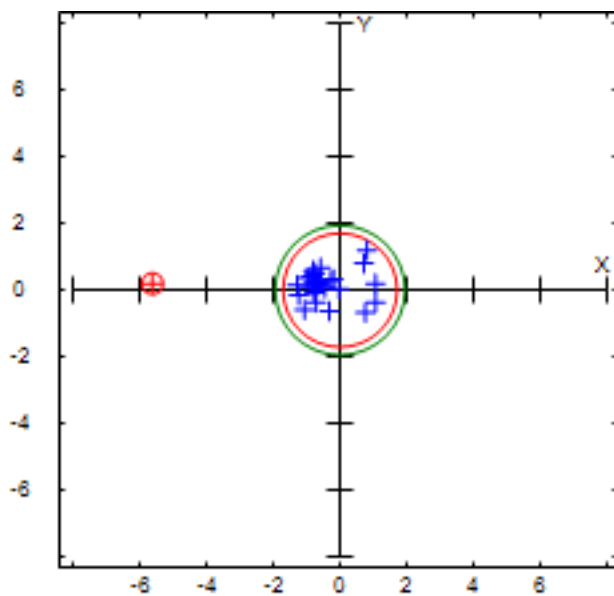
### Circular Error

Threshold: CE90: 1.706
