Project Information

Project Name: E911

Metadata Information

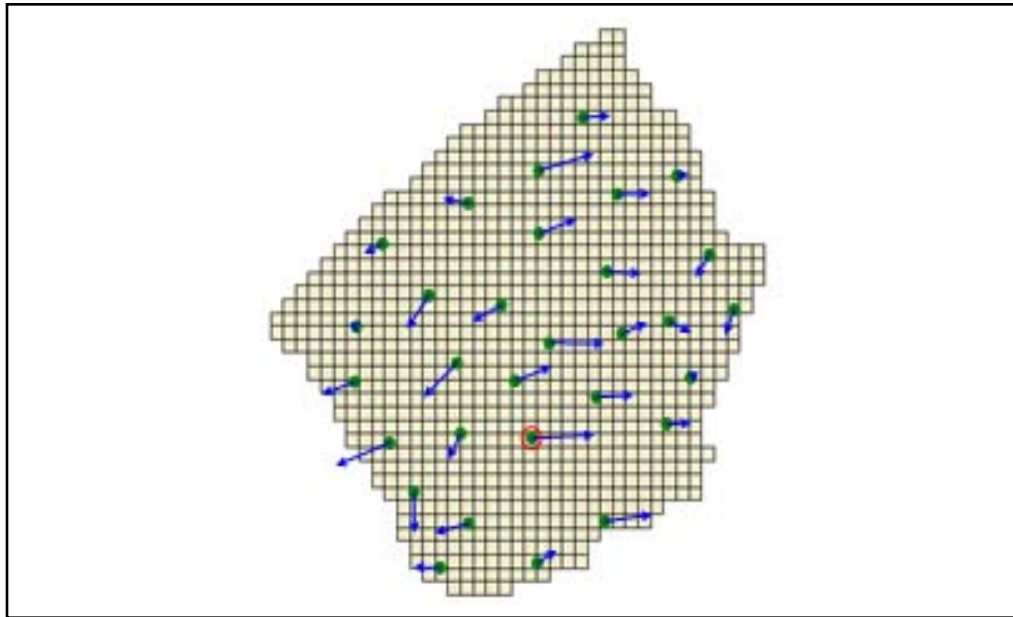
Vector Offset

Scaling Factor: 10000

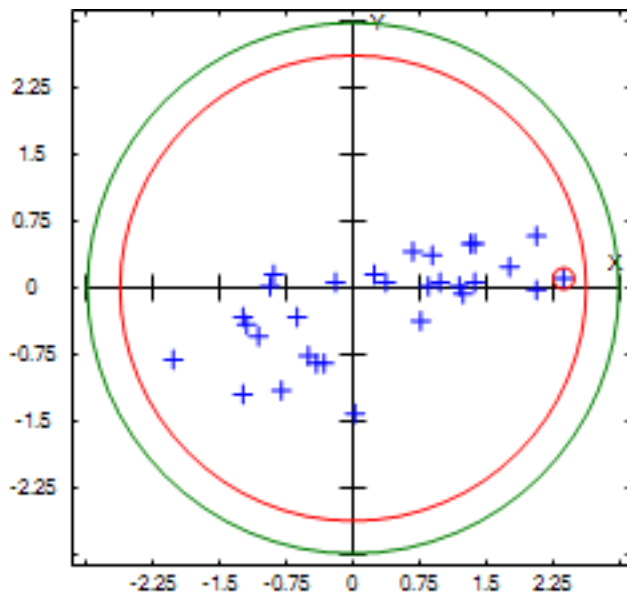
Circular Error

Min ΔX :	-2.018	Min ΔY :	-1.411	SX:	1.501
Max ΔX :	2.365	Max ΔY :	0.586	SY:	0.936
Mean ΔX :	0.269	Mean ΔY :	-0.191	SH:	1.219
Skew ΔX :	-0.003	Skew ΔY :	-0.696		
RmseX:	1.187	RmseY:	0.562	RmseH:	1.314
SRMSE H:	0.223				
CE 90:	2.616	CE 95:	2.983	CI:	0.436
No. Observations:	30				
Horiz. Bias:	0.33		NSSDA:	2.141

Threshold: CE90: 2.616
