## Project Information

Project Name: E911

## Metadata Information

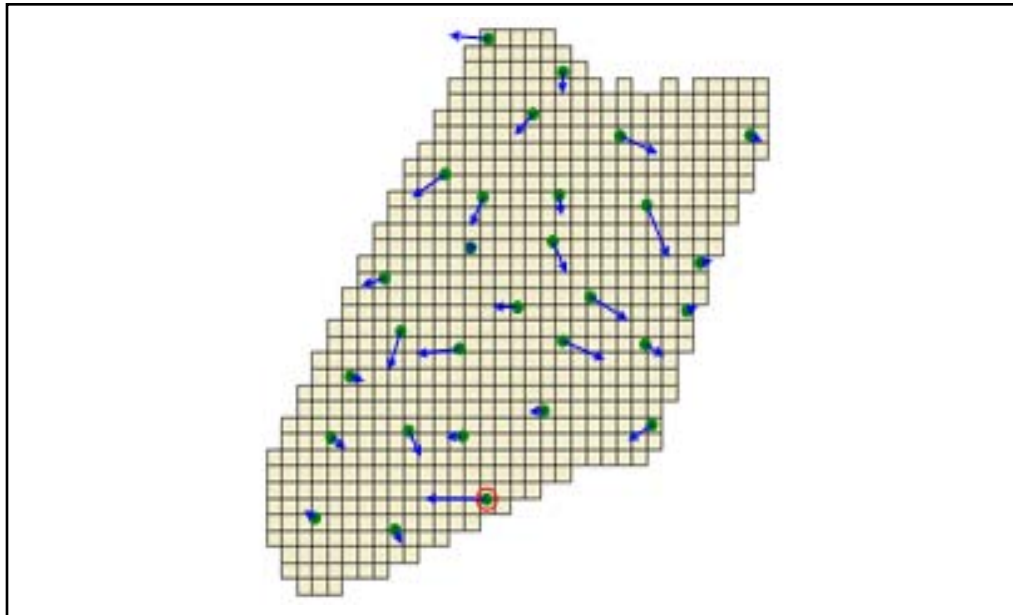
### Vector Offset

Scaling Factor: 10000

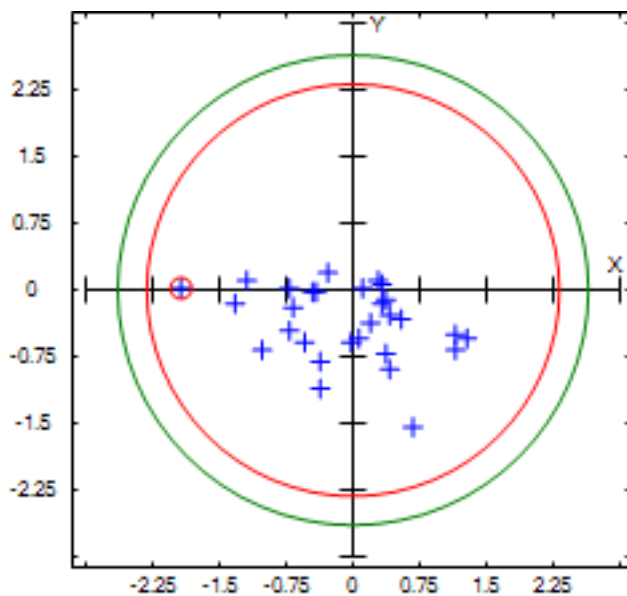
### Circular Error

Threshold: CE90: 2.317

Min $\Delta X$ :	-1.931	Min $\Delta Y$ :	-1.541	SX:	1.141
Max $\Delta X$ :	1.28	Max $\Delta Y$ :	0.195	SY:	1.018
Mean $\Delta X$ :	-0.082	Mean $\Delta Y$ :	-0.369	SH:	1.08
Skew $\Delta X$ :	-0.333	Skew $\Delta Y$ :	-0.875		
RmseX:	0.753	RmseY:	0.547	RmseH:	0.931
SRMSE H:	0.2				
CE 90:	2.317	CE 95:	2.643	CI:	0.393
No. Observations:	29				
Horiz. Bias:	0.378		NSSDA:	1.591
