Project Information

Project Name: E911

Metadata Information

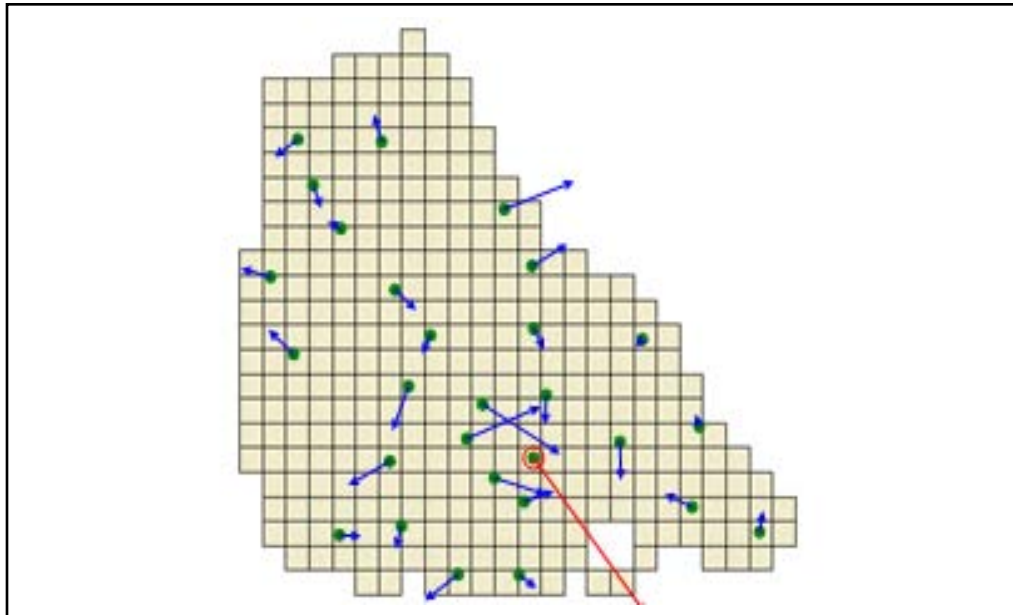
Vector Offset

Scaling Factor: 10000

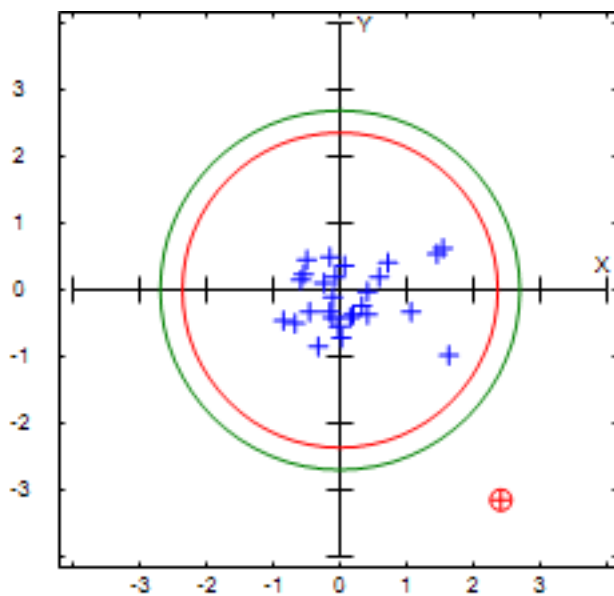
Circular Error

Min ΔX :	-0.846	Min ΔY :	-3.147	SX:	0.98
Max ΔX :	2.409	Max ΔY :	0.629	SY:	1.221
Mean ΔX :	0.222	Mean ΔY :	-0.225	SH:	1.101
Skew ΔX :	1.171	Skew ΔY :	-2.471		
RmseX:	0.8	RmseY:	0.743	RmseH:	1.092
SRMSE H:	0.208				
CE 90:	2.362	CE 95:	2.694	CI:	0.408
No. Observations:	28				
Horiz. Bias:	0.316		NSSDA:	1.889
