Project Information

Project Name: E911

Vendor Name: Floodplain

Metadata Information

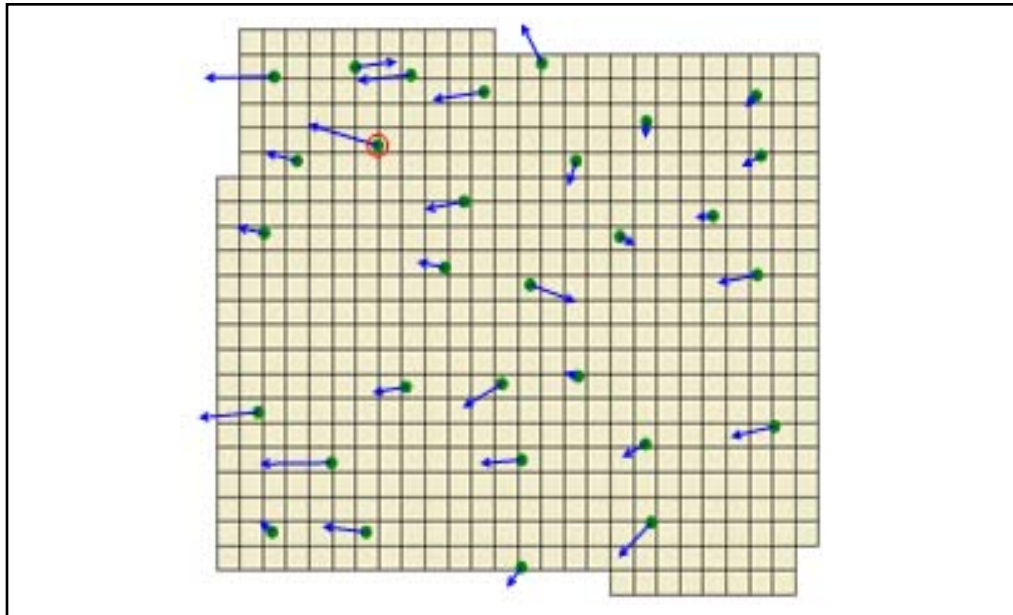
Vector Offset

Scaling Factor: 10000

Min ΔX :	-1.497	Min ΔY :	-0.673	SX:	1.49
Max ΔX :	0.933	Max ΔY :	0.76	SY:	0.457
Mean ΔX :	-0.551	Mean ΔY :	-0.081	SH:	0.974
Skew ΔX :	0.71	Skew ΔY :	0.746		
RmseX:	0.796	RmseY:	0.28	RmseH:	0.844
SRMSE H:	0.178				
CE 90:	2.09	CE 95:	2.383	CI:	0.348
No. Observations:	30				
Horiz. Bias:	0.557		NSSDA:	1.317

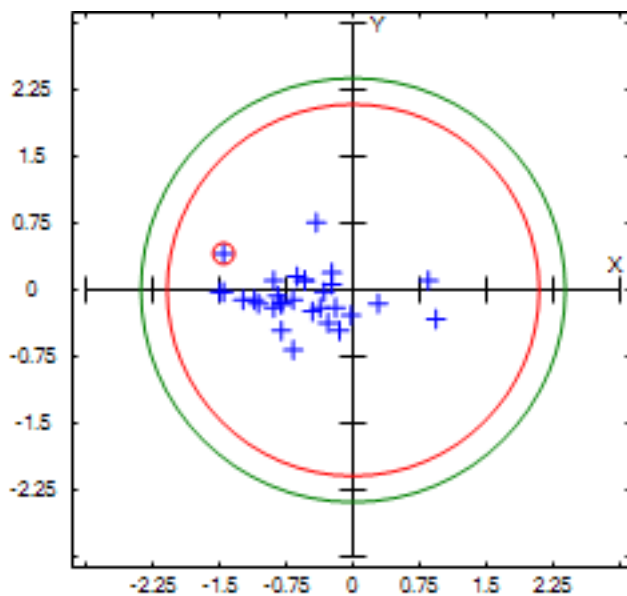
Circular Error

Threshold: CE90: 2.09
