Prepared By: Steve Kaufman

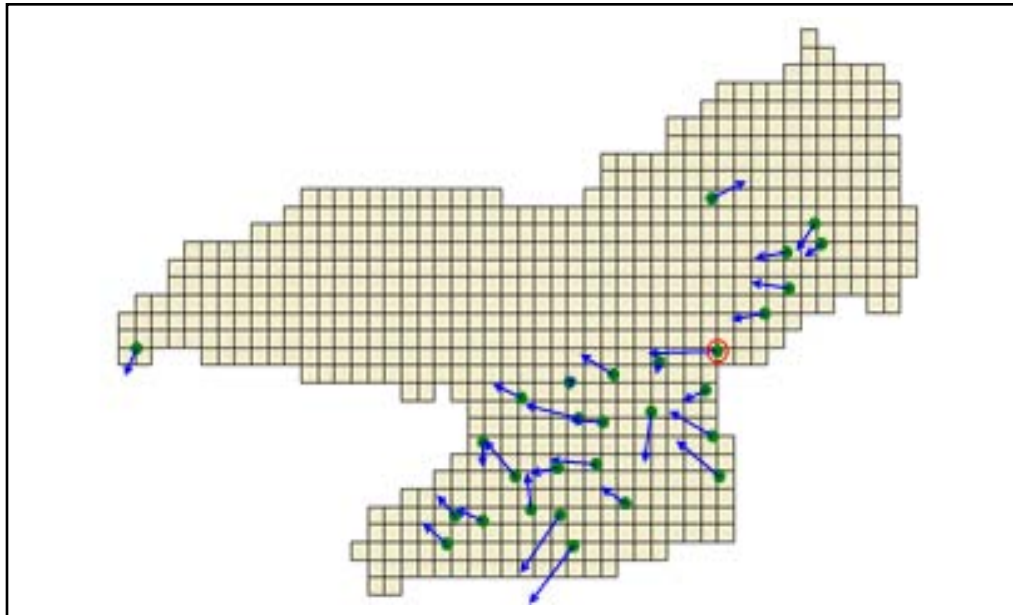
Vector Offset

Scaling Factor: 10000

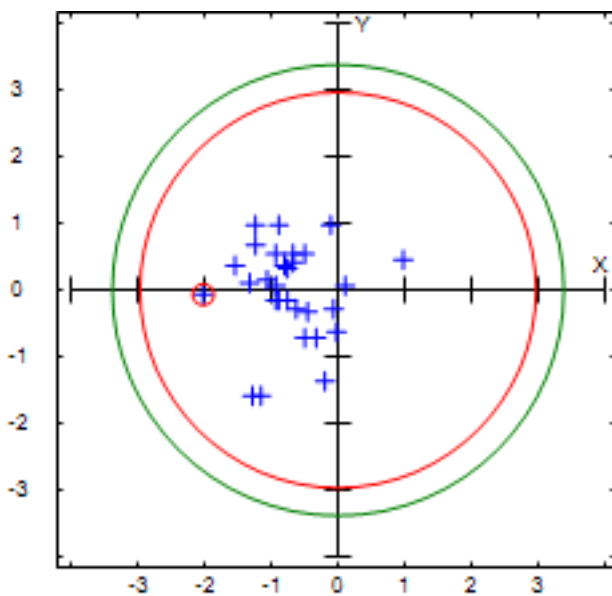
Circular Error

Min ΔX :	-2.018	Min ΔY :	-1.584	SX:	1.765
Max ΔX :	0.977	Max ΔY :	0.977	SY:	0.998
Mean ΔX :	-0.718	Mean ΔY :	-0.016	SH:	1.382
Skew ΔX :	0.56	Skew ΔY :	-0.796		
RmseX:	0.919	RmseY:	0.686	RmseH:	1.147
SRMSE H:	0.257				
CE 90:	2.965	CE 95:	3.382	CI:	0.503
No. Observations:	29				
Horiz. Bias:	0.718		NSSDA:	1.964
