Project Information

Project Name: E911

Metadata Information

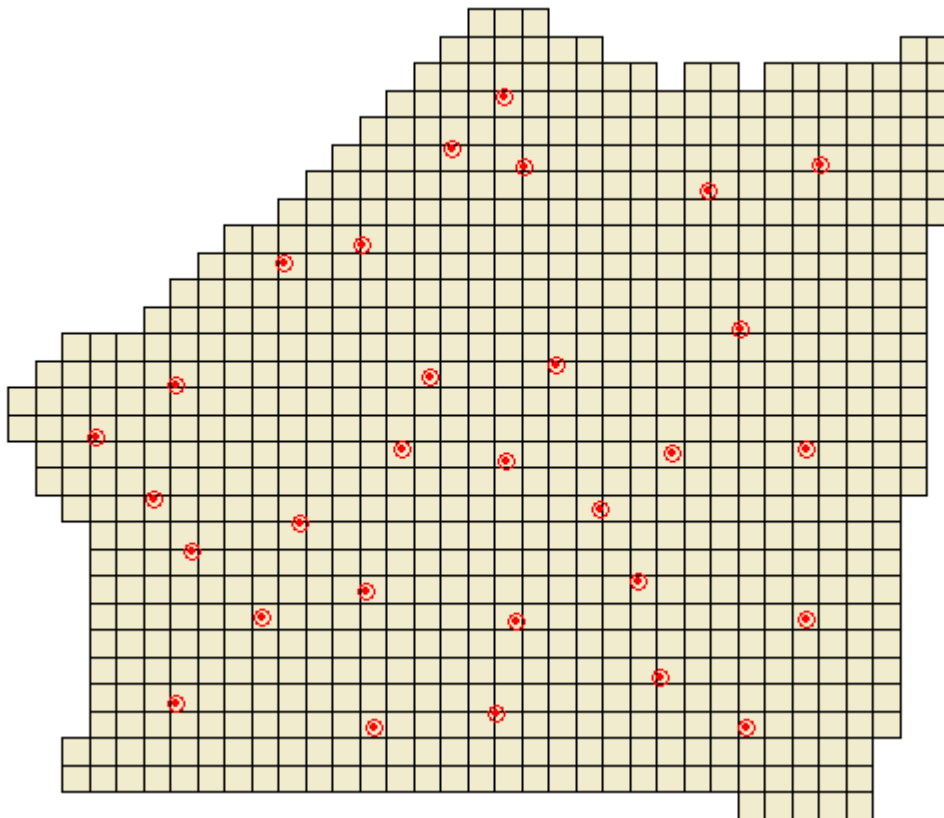
Tiled-Image Area

Index File Name: Union2010_index.shp

of Polygons: 789

of Matching Images: 789

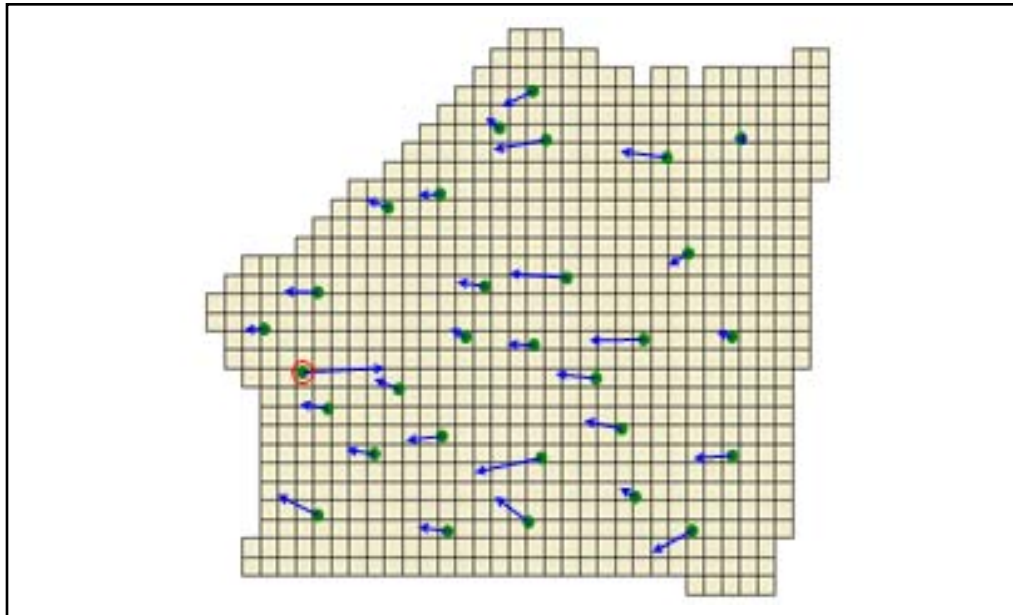
Vector Offset

Scaling Factor: 10000

Min ΔX :	-1.801	Min ΔY :	-0.543	SX:	1.868
Max ΔX :	2.235	Max ΔY :	0.629	SY:	0.316
Mean ΔX :	-0.719	Mean ΔY :	0.043	SH:	1.092
Skew ΔX :	2.66	Skew ΔY :	-0.205		
RmseX:	0.988	RmseY:	0.242	RmseH:	1.018
SRMSE H:	0.199				
CE 90:	2.344	CE 95:	2.673	CI:	0.391
No. Observations:	30				
Horiz. Bias:	0.72		NSSDA:	1.506

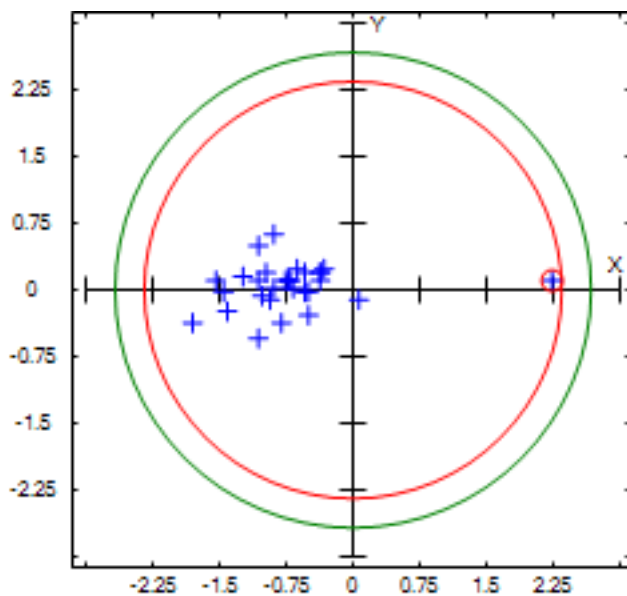
Circular Error

Threshold: CE90: 2.344
