Project Information

Project Name: E911

Metadata Information

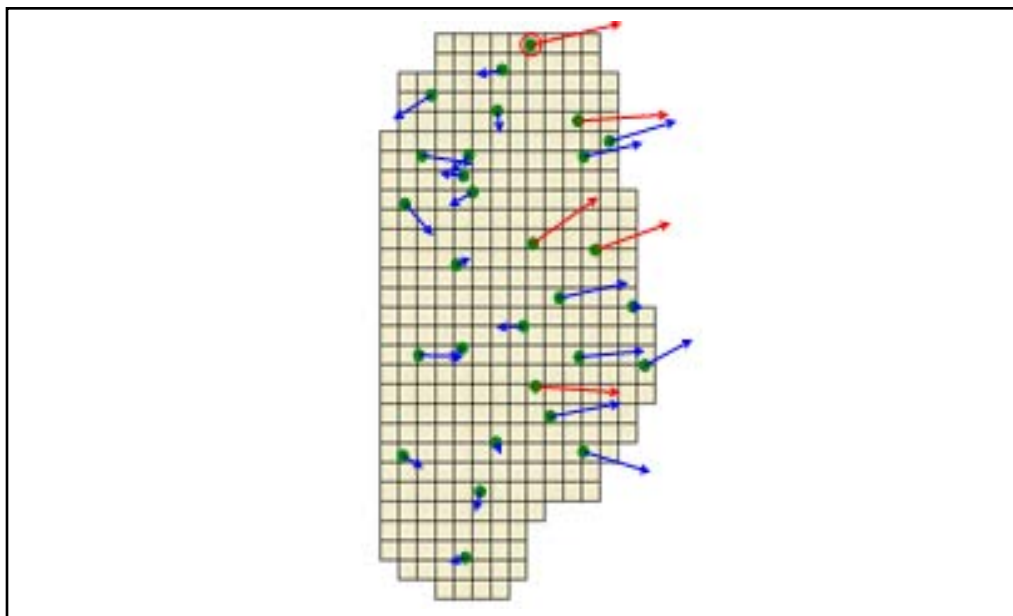
Vector Offset

Scaling Factor: 10000

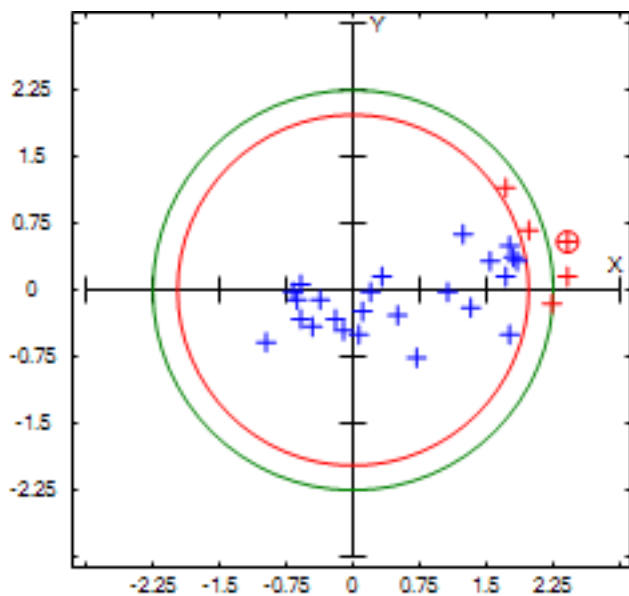
Circular Error

Min ΔX :	-0.977	Min ΔY :	-0.76	SX:	1.219
Max ΔX :	2.409	Max ΔY :	1.15	SY:	0.619
Mean ΔX :	0.763	Mean ΔY :	0.001	SH:	0.919
Skew ΔX :	-0.023	Skew ΔY :	0.597		
RmseX:	1.31	RmseY:	0.43	RmseH:	1.379
SRMSE H:	0.171				
CE 90:	1.972	CE 95:	2.25	CI:	0.335
No. Observations:	29				
Horiz. Bias:	0.763		NSSDA:	2.13
