Project Information

Project Name: E911

Metadata Information

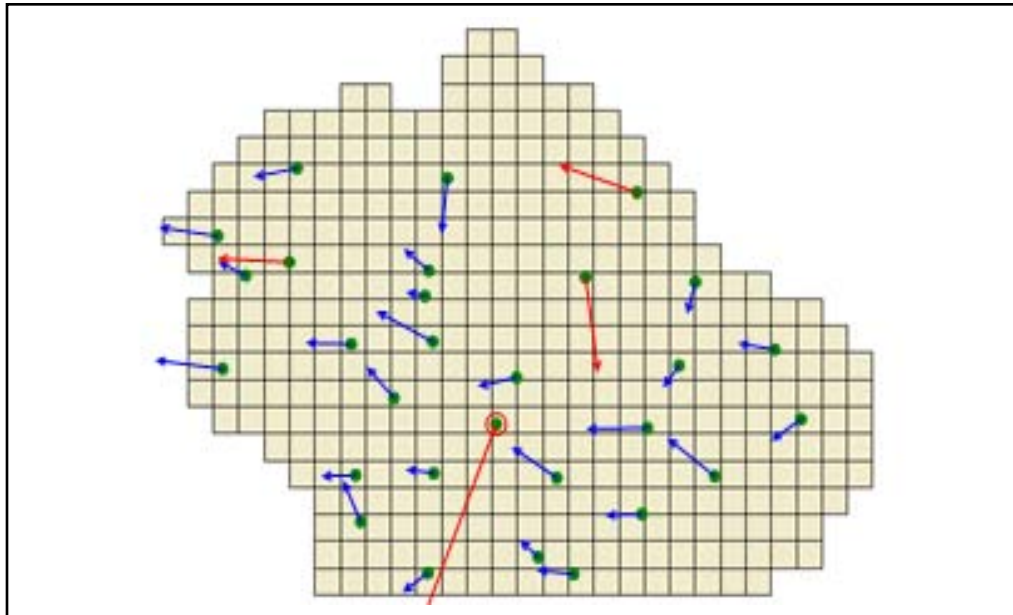
Vector Offset

Scaling Factor: 10000

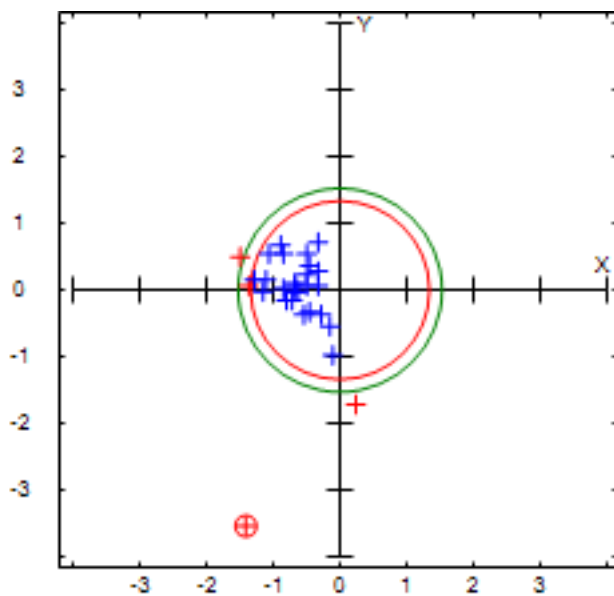
Circular Error

Threshold: CE90: 1.339

Min ΔX :	-1.497	Min ΔY :	-3.537	SX:	0.419
Max ΔX :	0.239	Max ΔY :	0.716	SY:	0.829
Mean ΔX :	-0.685	Mean ΔY :	-0.107	SH:	0.624
Skew ΔX :	-0.166	Skew ΔY :	-2.893		
RmseX:	0.799	RmseY:	0.822	RmseH:	1.146
SRMSE H:	0.116				
CE 90:	1.339	CE 95:	1.527	CI:	0.227
No. Observations:	29				
Horiz. Bias:	0.693		NSSDA:	1.983
